INCIDENT NOTICE

INCIDENT TITLE: Smoke coming from AN auger bearing.

DATE POSTED	REFERENCE	SOURCE
20 December 2022	IN 22-11	Austin Powder
INCIDENT OUTLINE		
When did it happen?	July 22 nd , 2022	
Who experienced it?	Austin Powder Company, USA	
Where did it happen?	Red Diamond bulk emulsion & mix plant	
What material was involved?	Bulk Emulsion & AN prills	
What happened?	While attempting to empty the Ammonium Nitrate Prill Bin, an operator noticed that there was smoke developing from the bearing of the mixing auger and immediately stopped the auger. He then sprayed the bearing assembly with water to reduce the temperature.	
Why did it happen – theory?	Bearing failure. Lack of preventive maintenance. Corrosive atmosphere from AN dust.	
What was the impact?	Nobody was injured. Production was delayed until bearing was replaced.

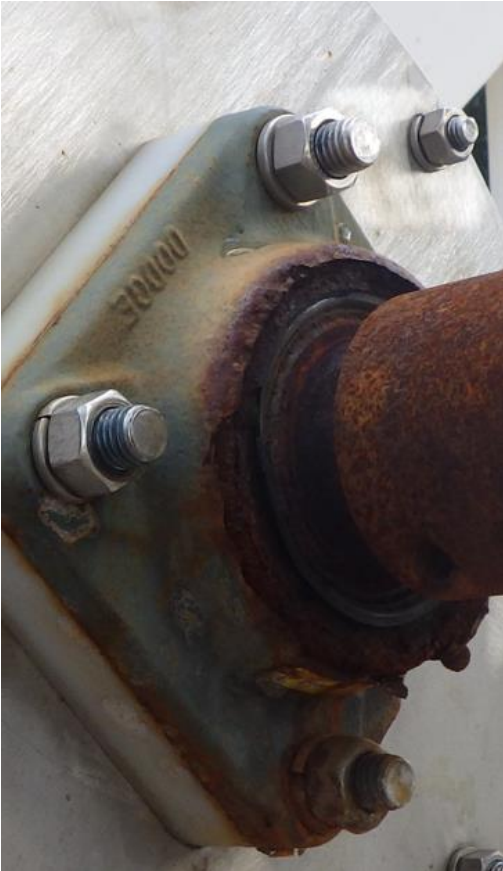
Clear evidence of failed bearing: outside corrosion, not lubricated

The importance of having an efficient preventive maintenance plan that covers all parts subject to wear with special attention to bearings and seals that may come in contact with emulsions and ammonium nitrate (dust). Timely replacement before they fail is an effective way to control the source of heat by friction.

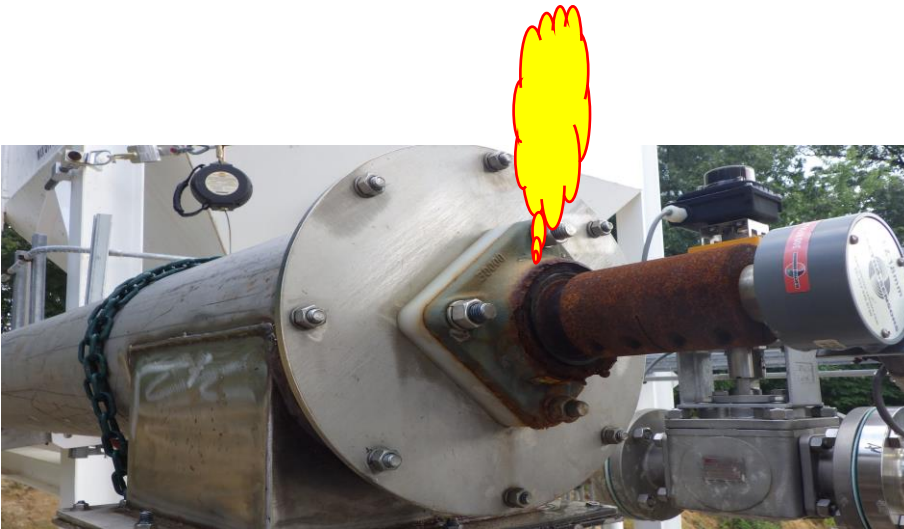
Place where smoke was detected

Note: There is a plastic plate (spacer) to prevent interior contact of the bearing with AN. The plate has an opening at the bottom (which is hard to identify in the picture)
